Subjects: Dock and Sea Trials "RTA 1" Catamaran Passenger Ferry
Metal Shark Franklin, LA.

The following was observed during my visit of April 27, 2018

First Catamaran Ferry "RTA 1"

Two (2) 32.0 (m) X 7.7 (m) X 1.35(m)RTA Passenger Ferries

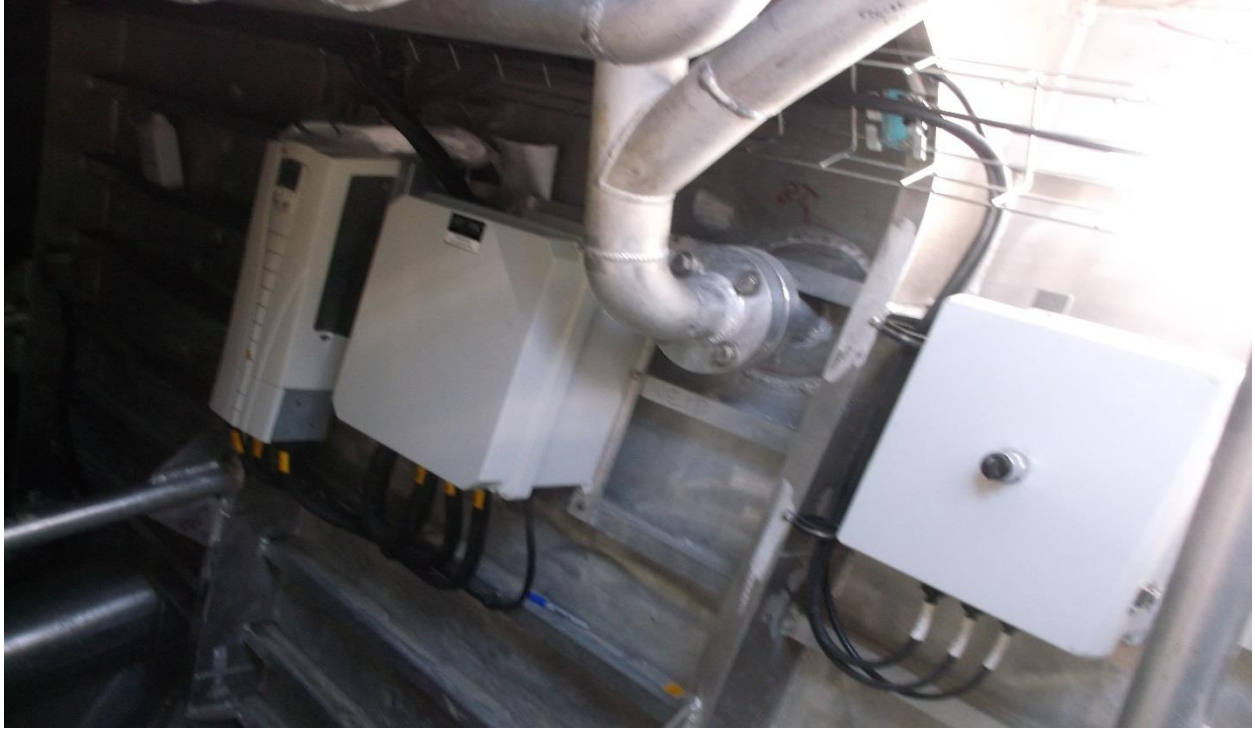
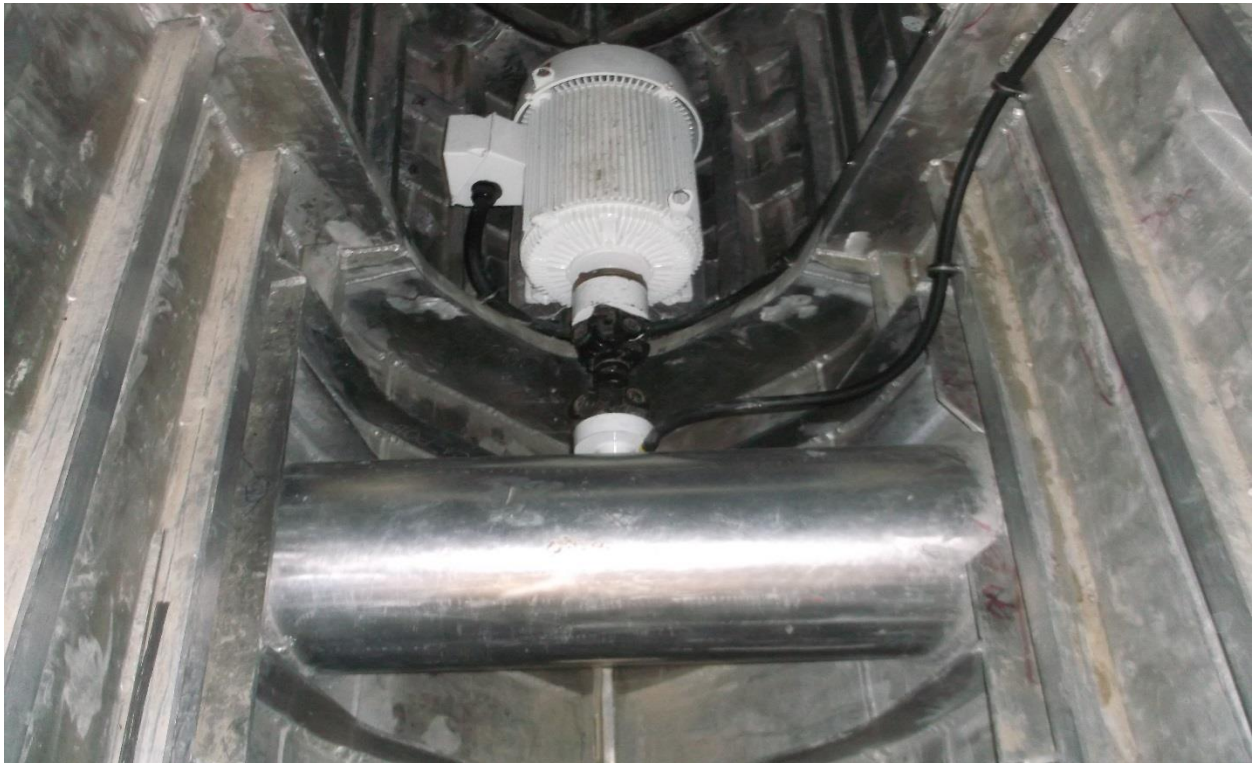
No.2 starboard hull compartment views of electrical panels and bow thruster motor with drive connected

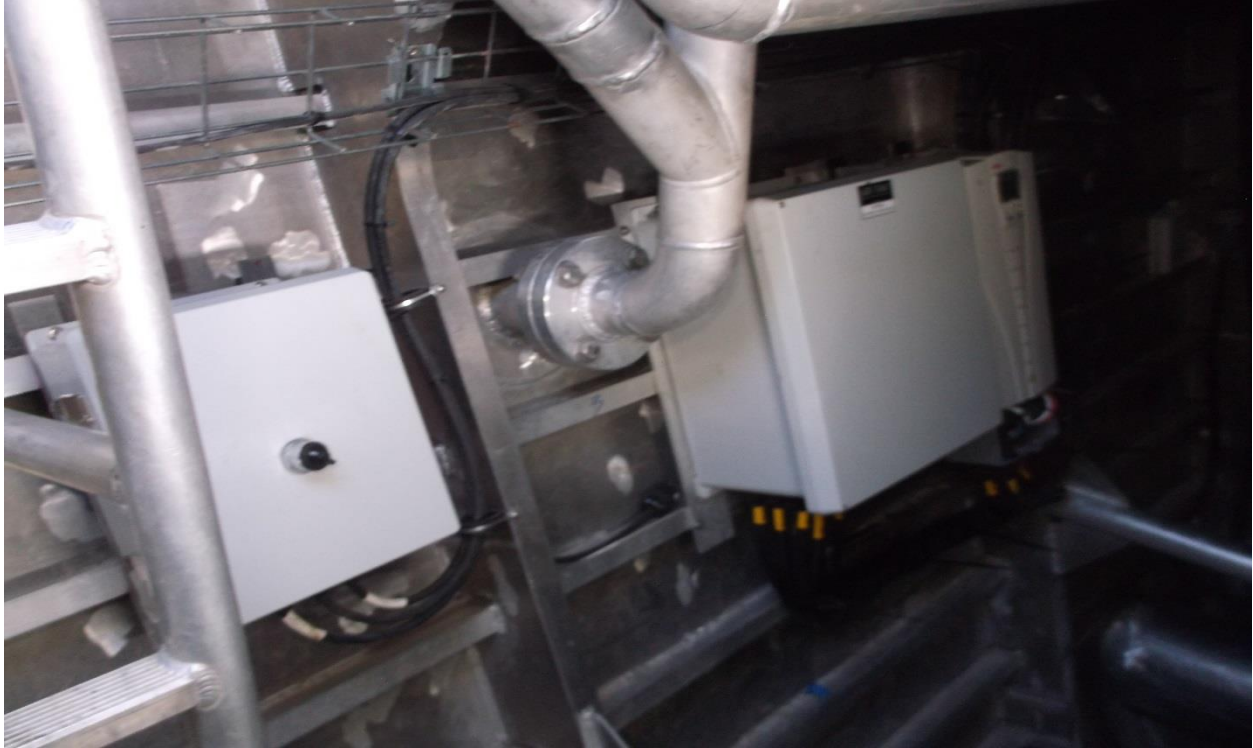
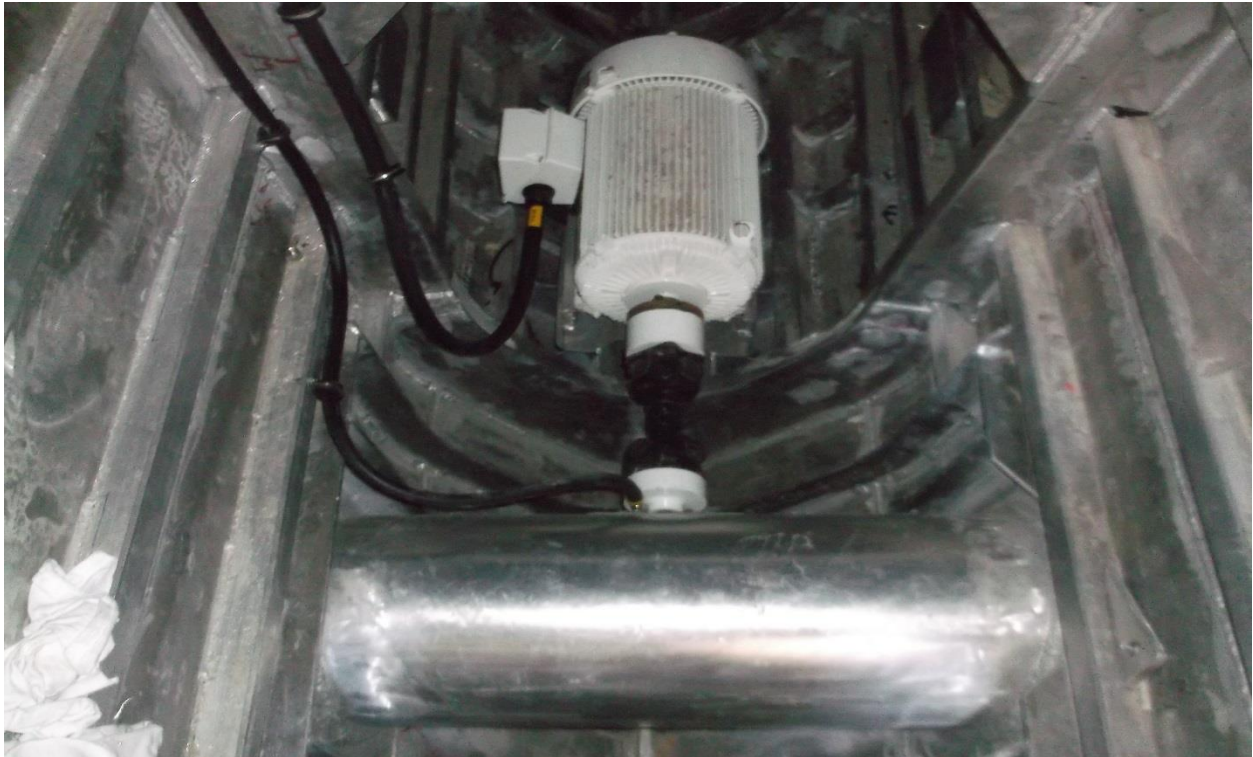
No.2 port hull compartment views of electrical panels and thruster motor with drive connected

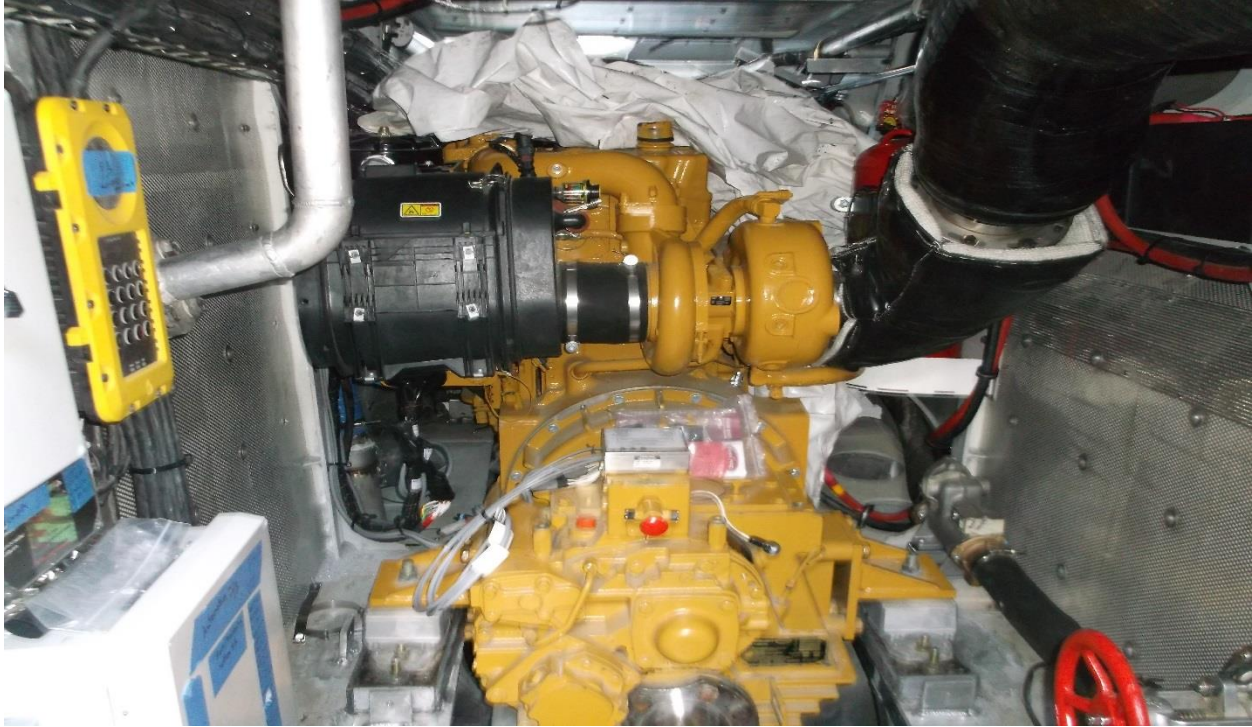
No.4 port hull machinery space having exhaust system connected to main engine

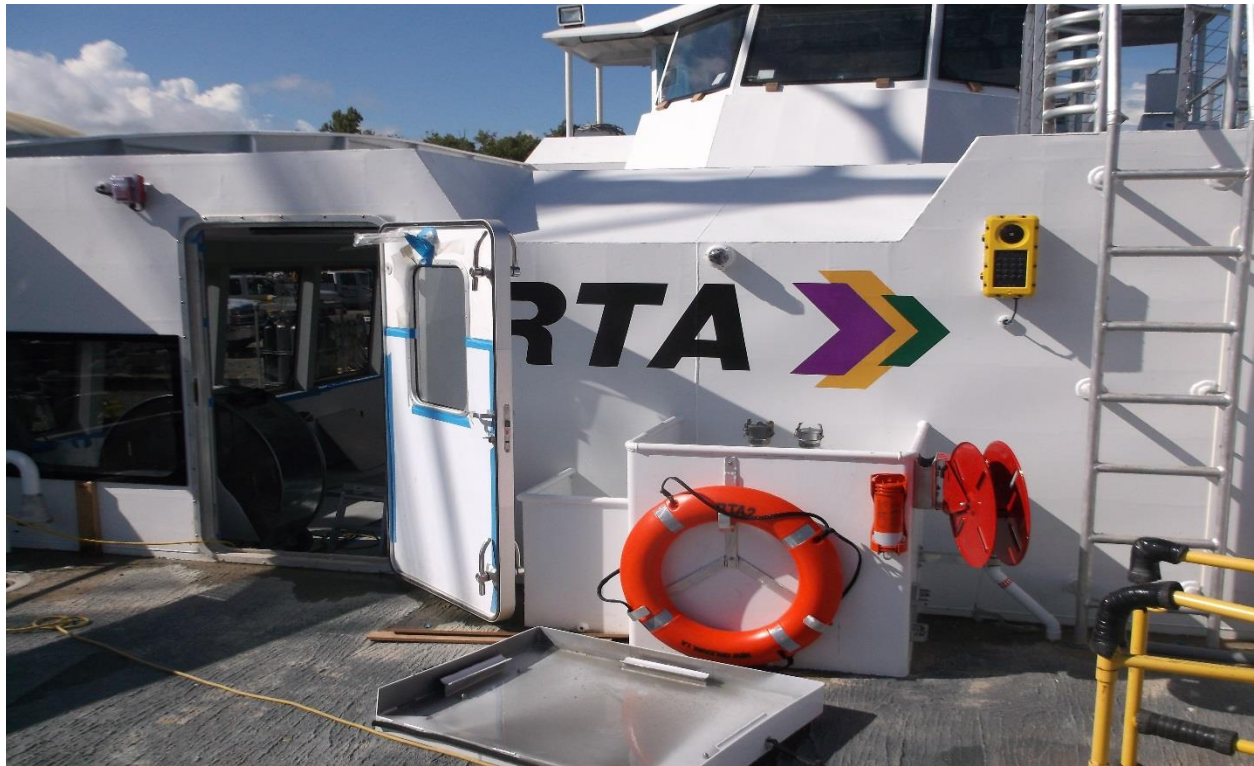
View of bow main deck with hailing system, fire hose reel, life buoy and light installed

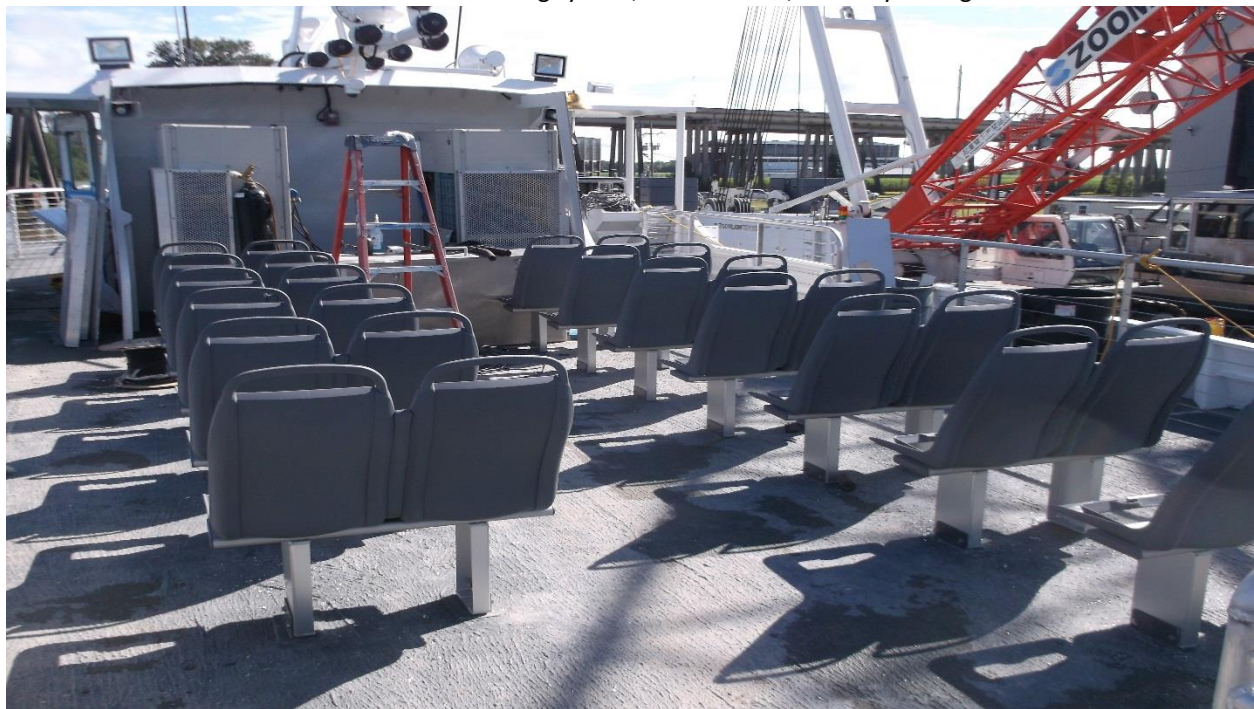
Upper deck having seating foundations installed

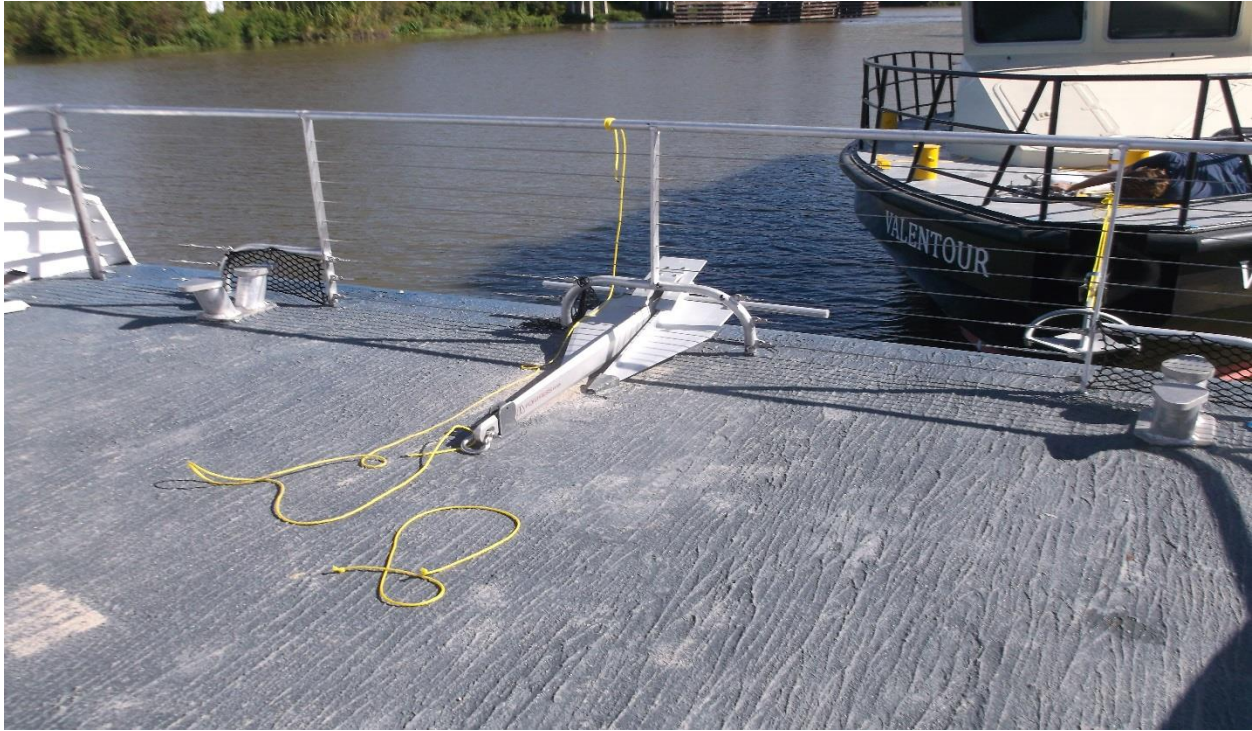
Bow deck with anchor installed

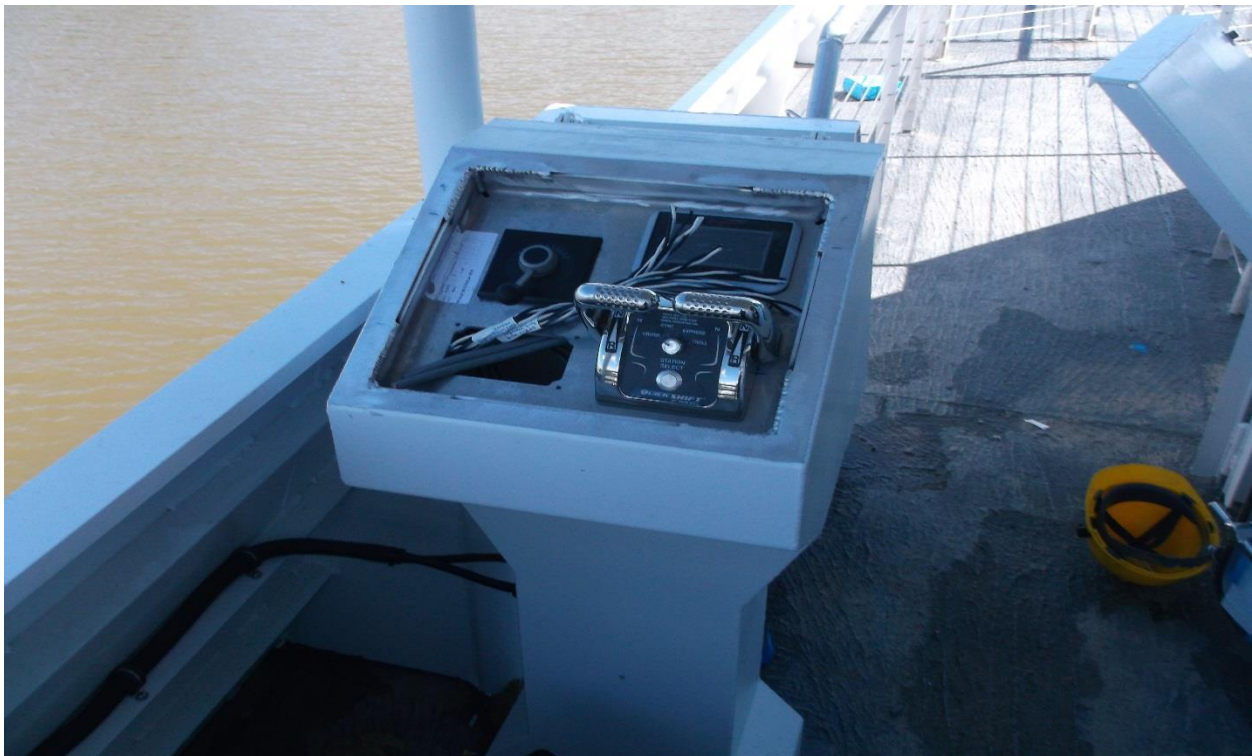
Typical view of wing stations with controls placed with wiring pulled for installation

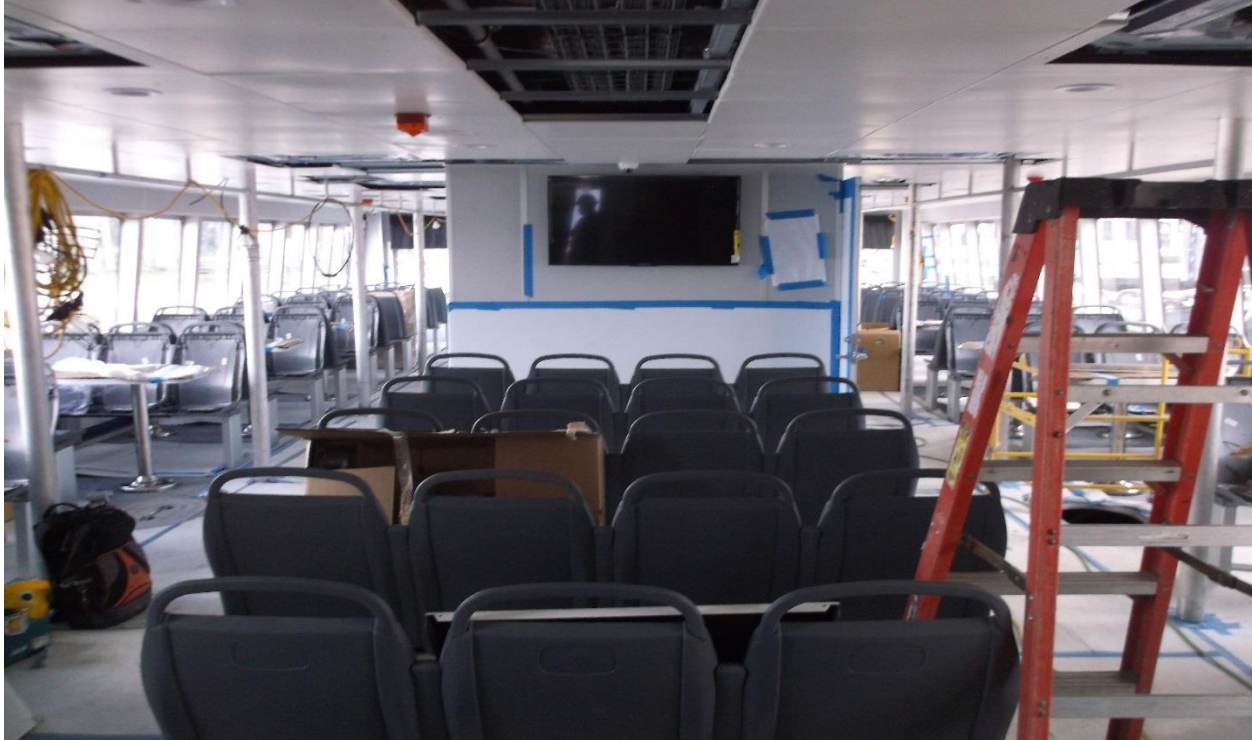
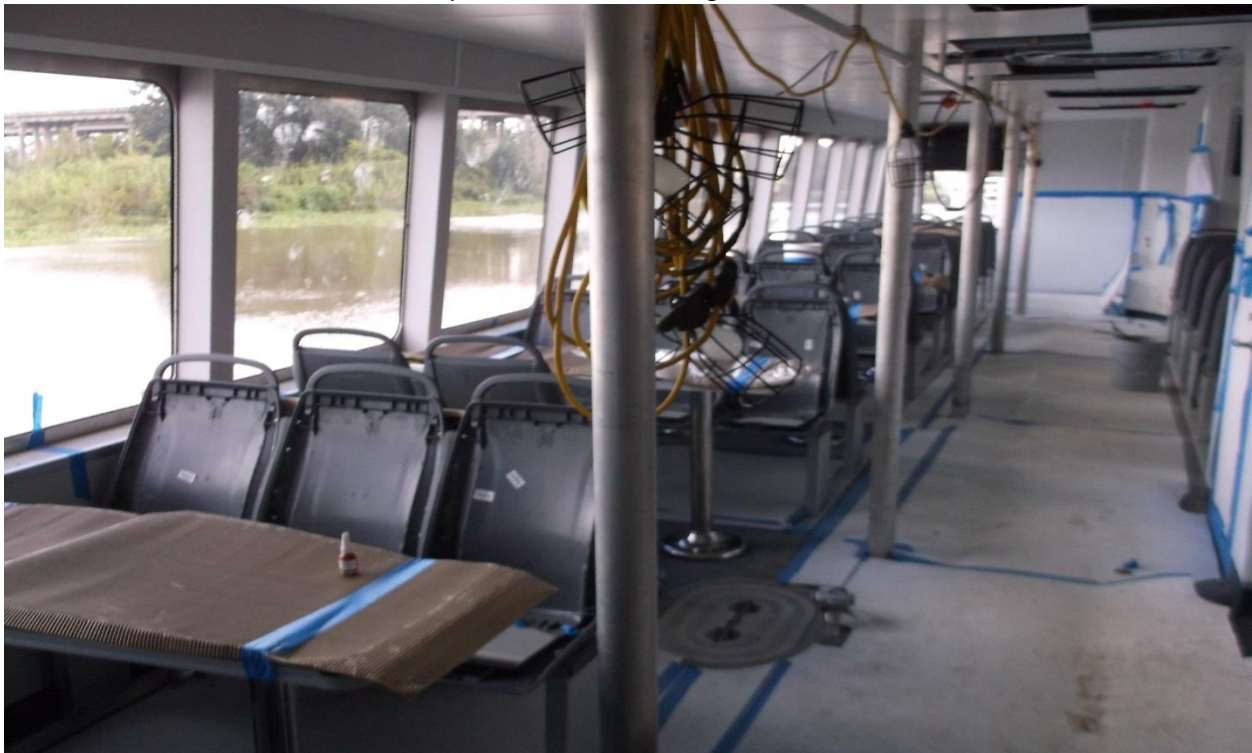
Aft center and portside views of seating and monitors installed

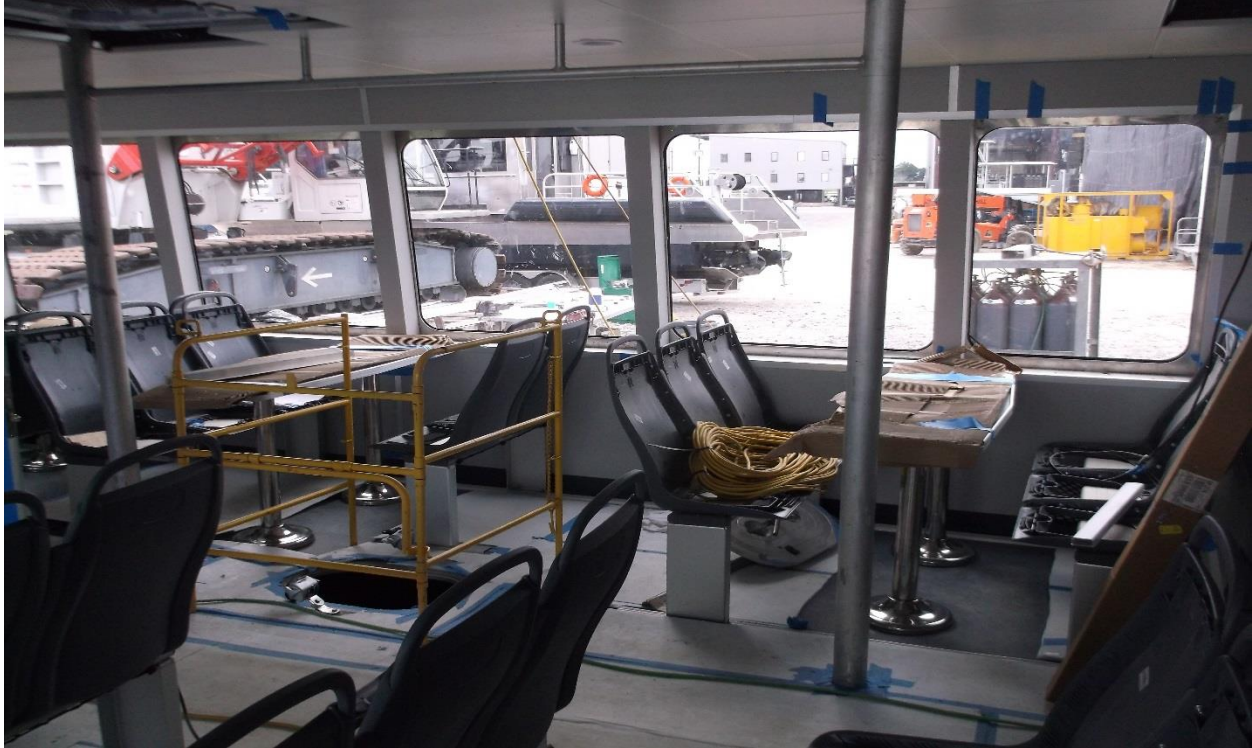
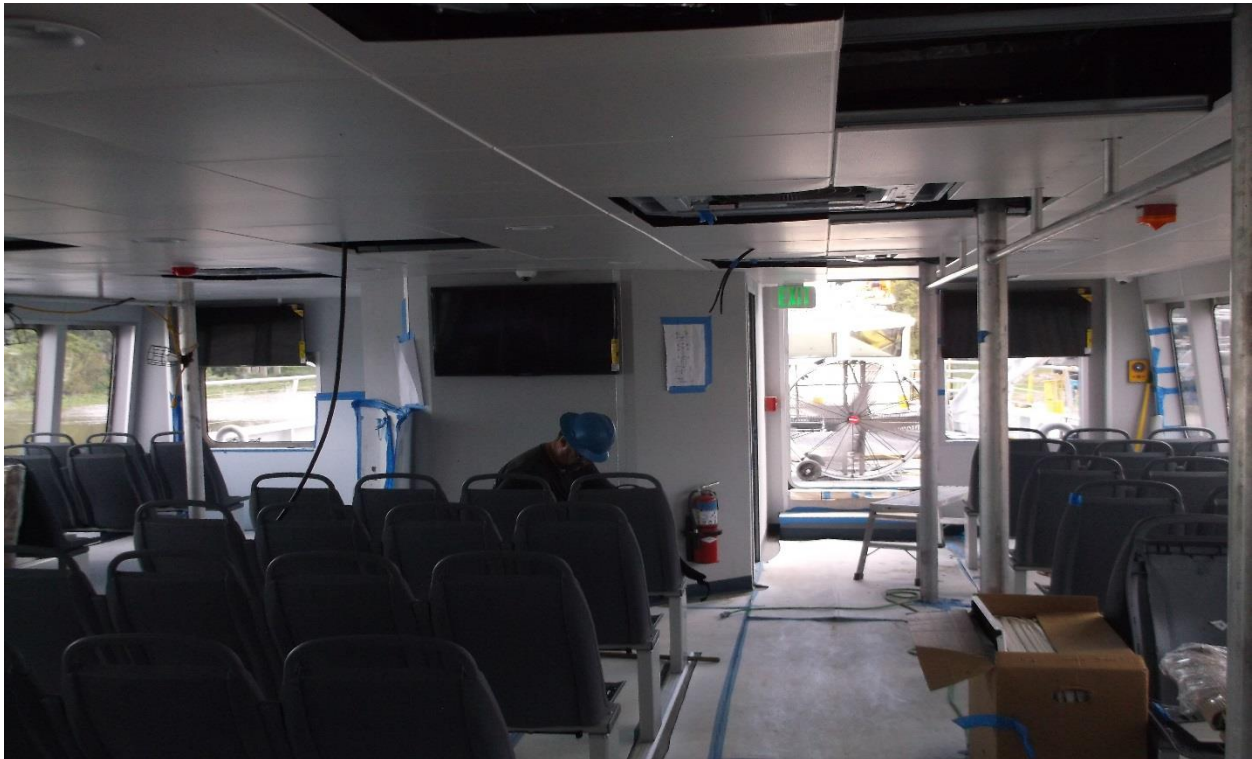
Views of starboard side table seating and forward center seating and monitors installed

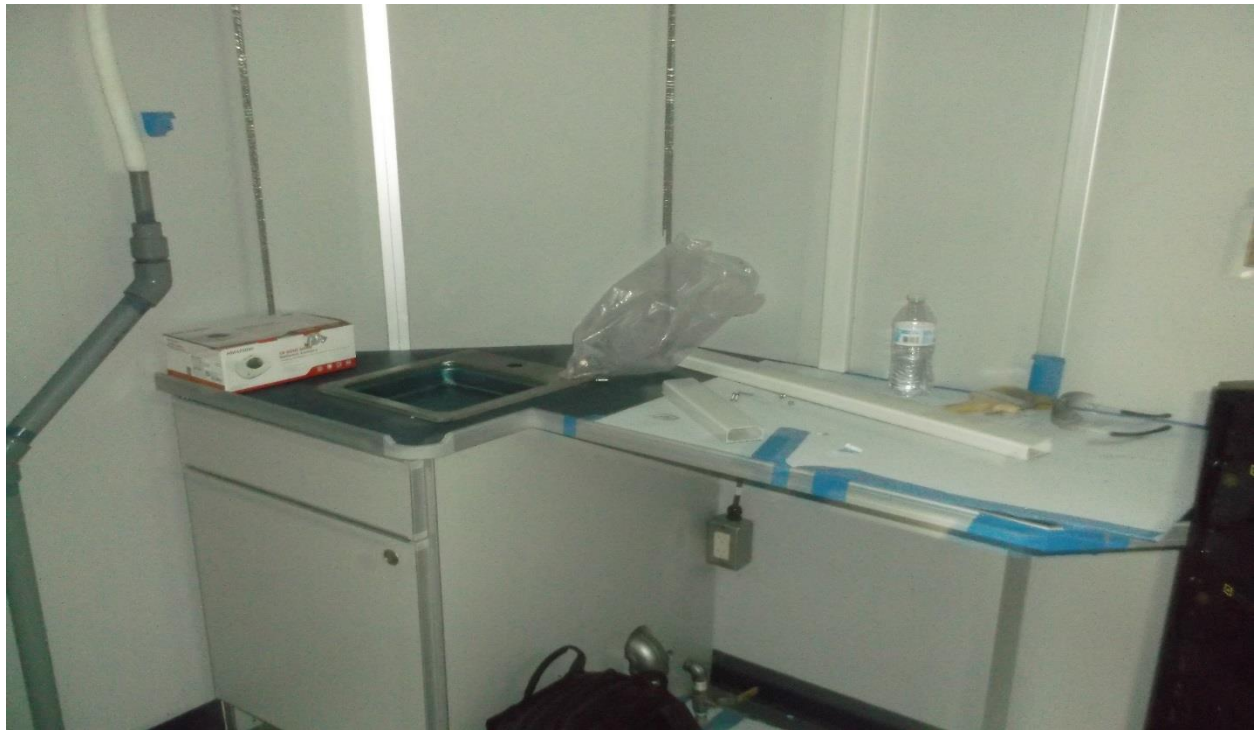
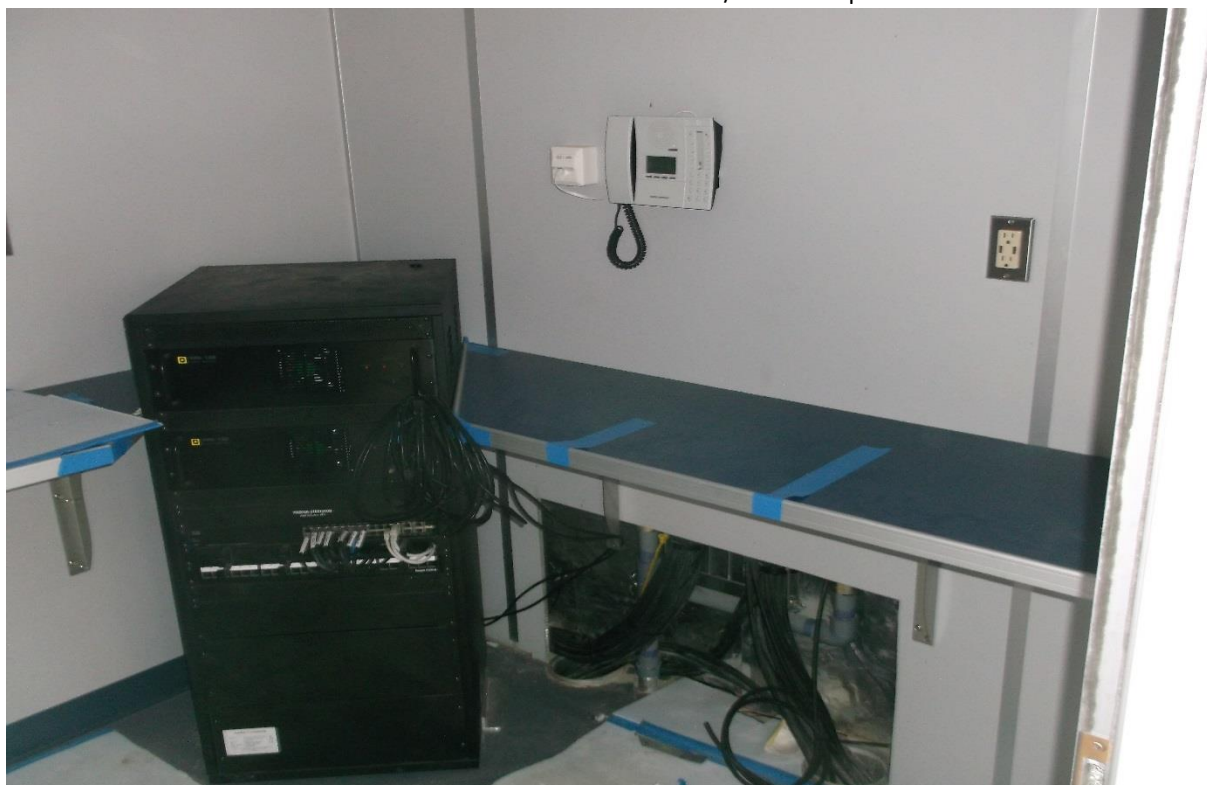
Views inside crew office of sink/counter tops

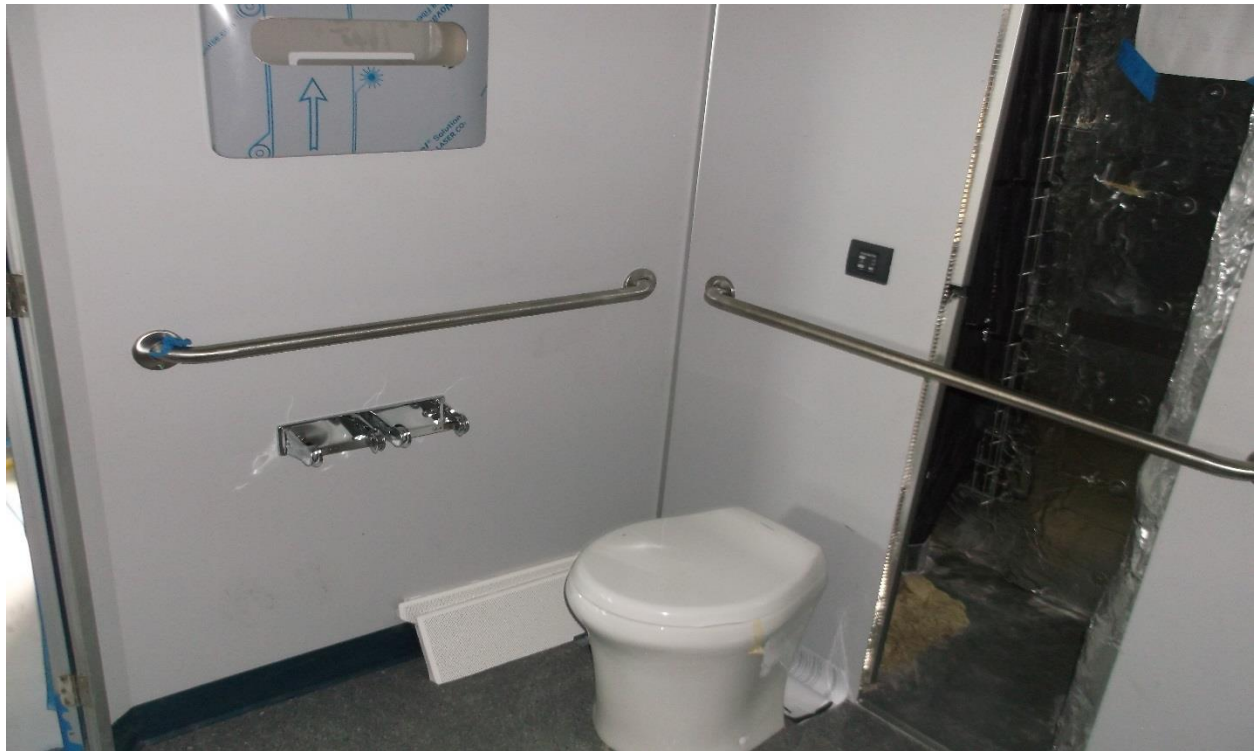
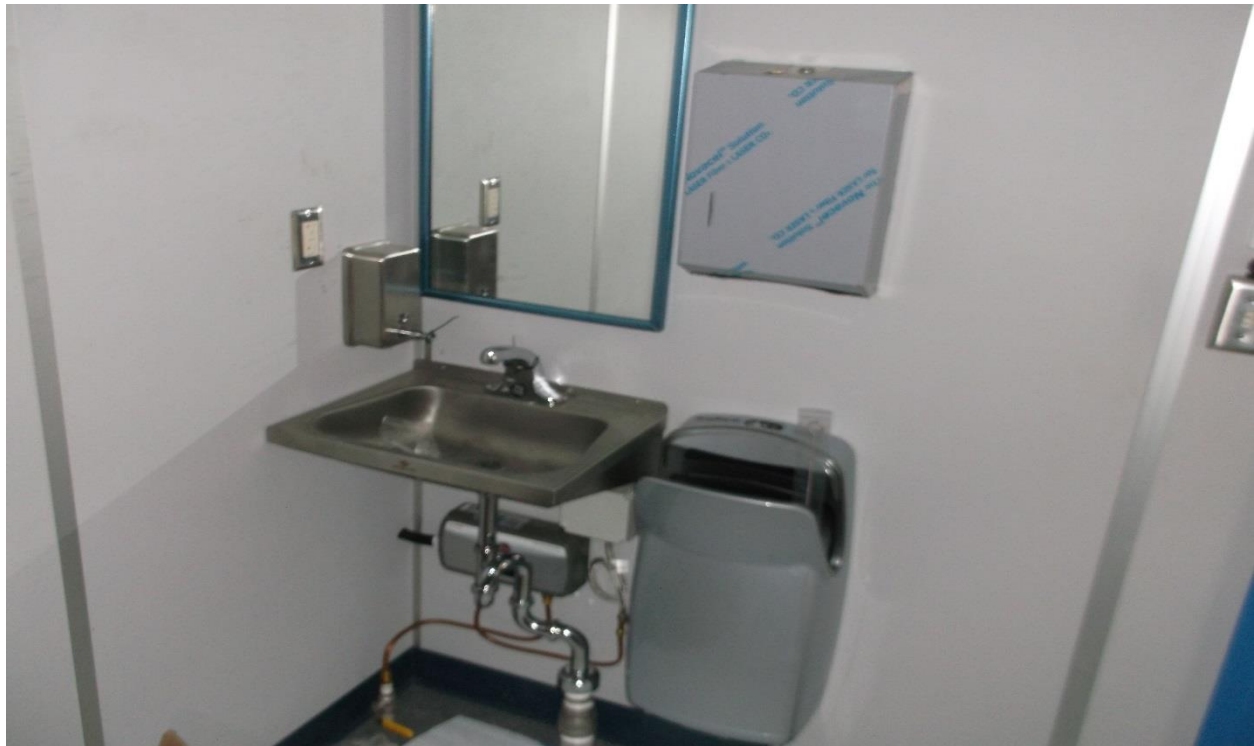
Views inside the ADA head with handrails, sink, paper and soap dispensers and hand dryer/sanitizer

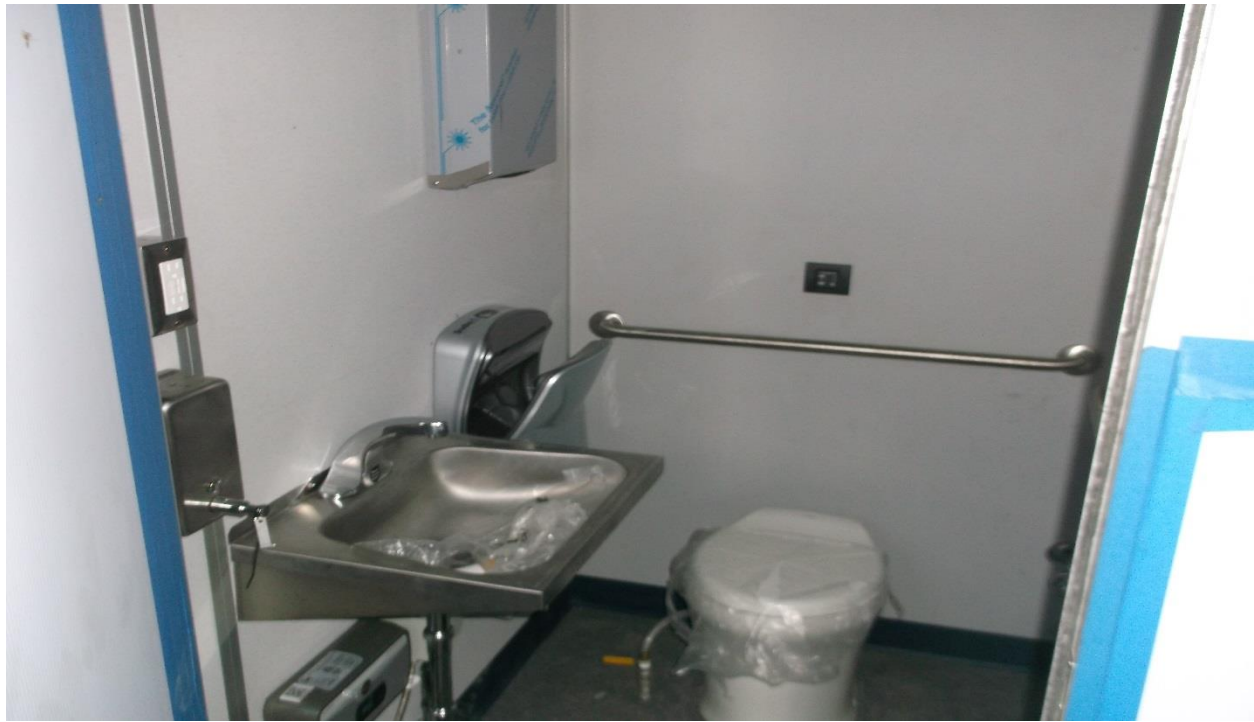
Views inside standard head with all amenities (above) and below photo of service locker/electrical room

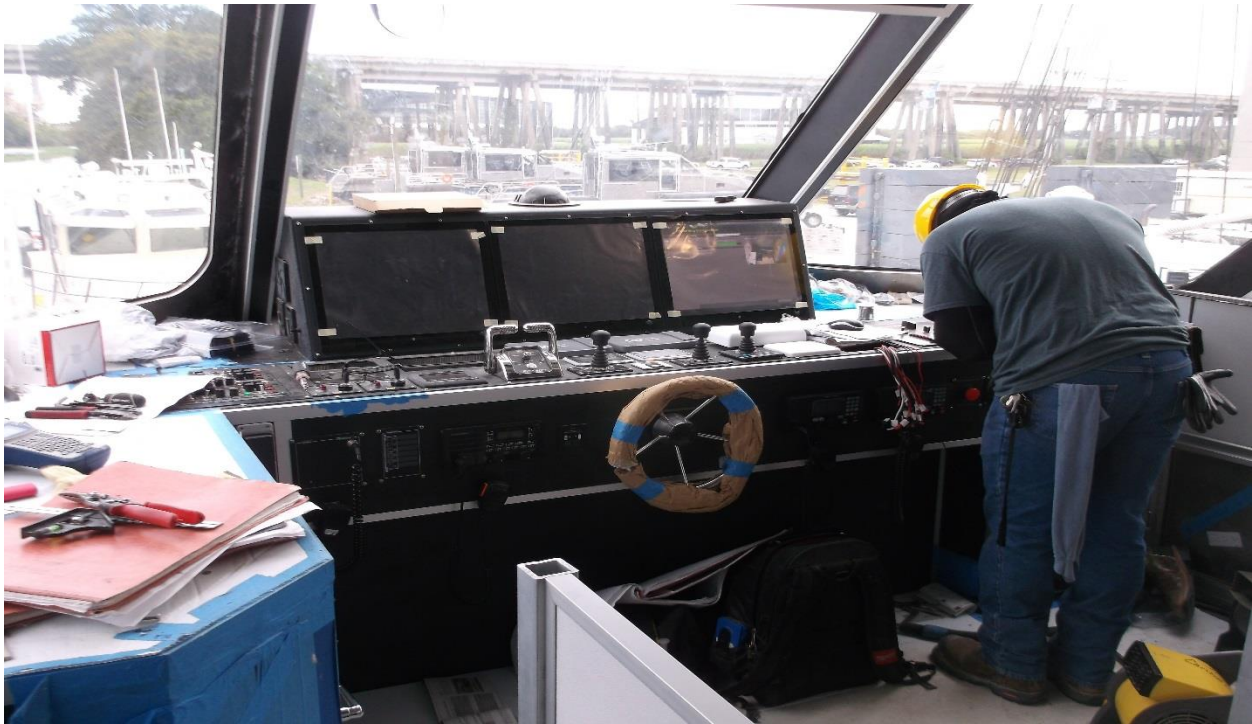
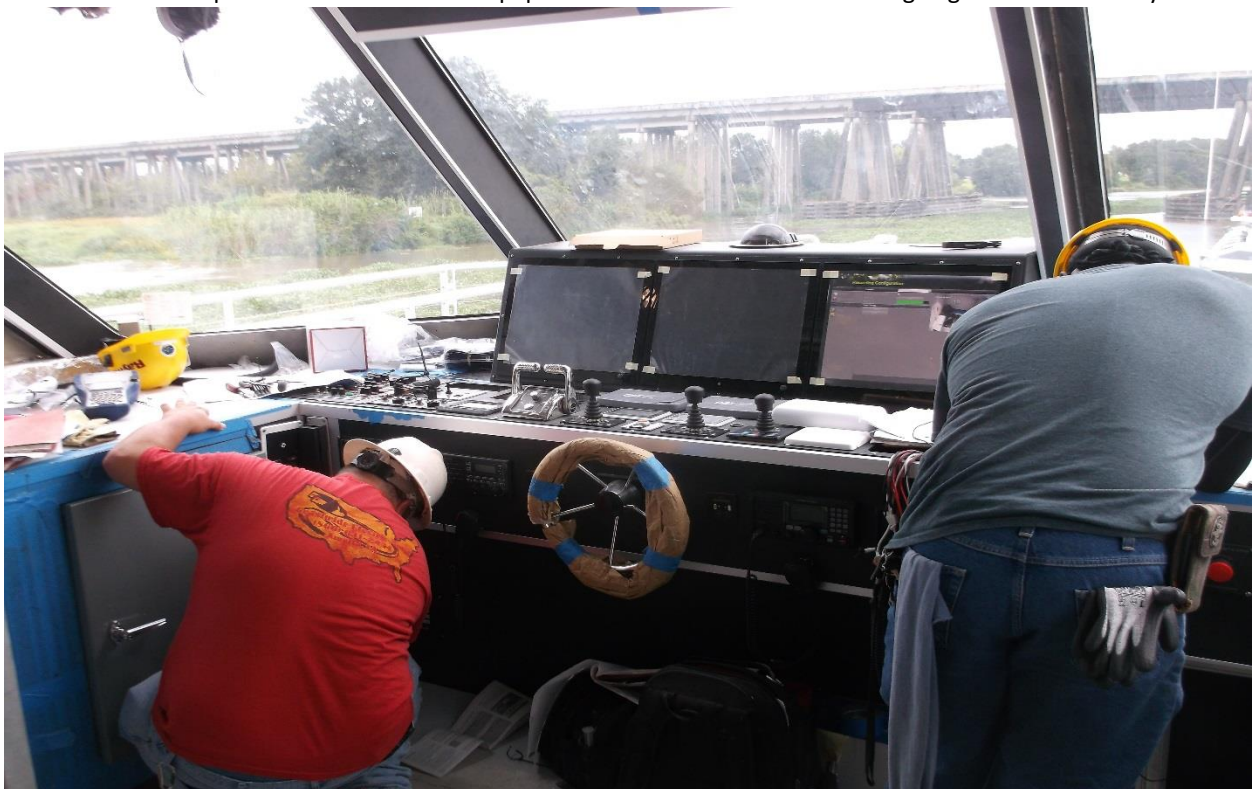
Views inside the pilothouse with most of equipment installed and workers testing bilge and fire alarm systems

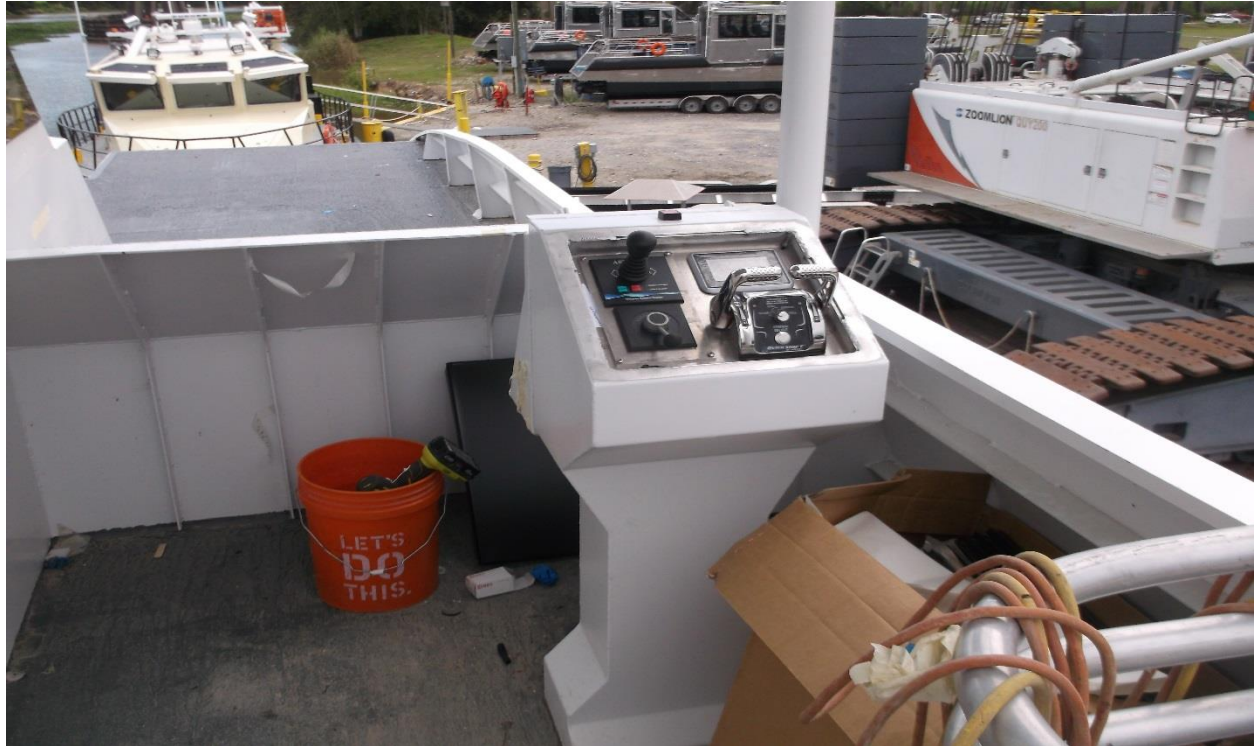
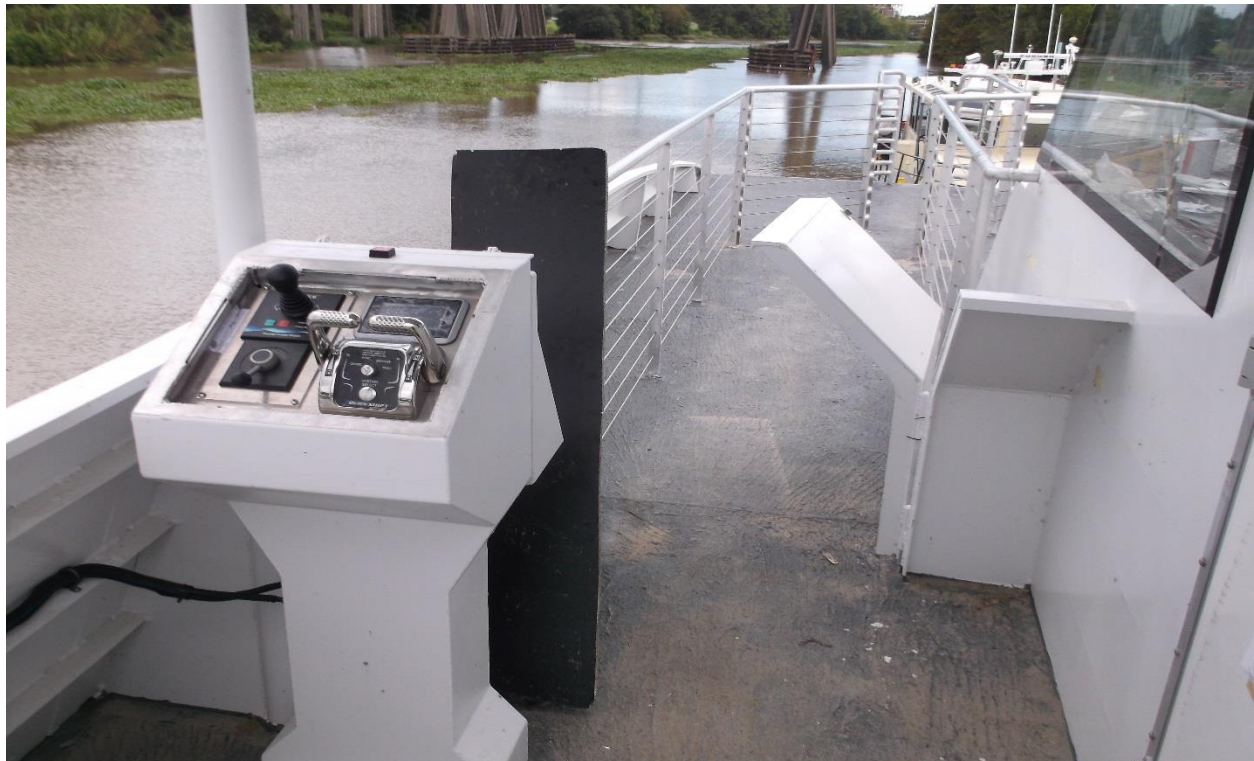
Views of wing vessel stations having all control wired into the system

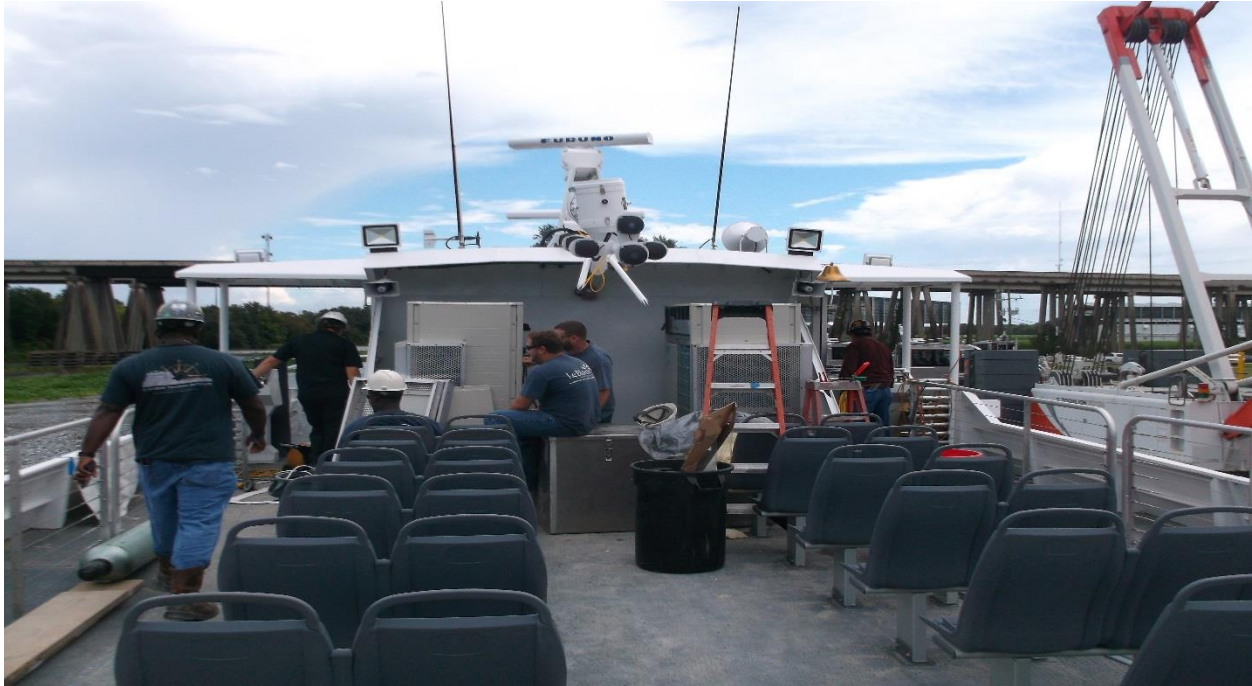
HVAC contractor monitoring system as it was being ran onboard the vessel
